Fernandina old Wall of Lisbon – Characterization towards its preservation

Leandro Gomes¹, Paulina Faria², Vitor Silva¹, António Santos Silva³

GOMES L., FARIA P., SILVA V., SANTOS SILVA A. (2019), Fernandina old Wall of Lisbon – Characterization towards its preservation. HMC2019 - 5th Historic Mortars Conference, 19-21 June 2019, Pamplona. RILEM Proceedings PRO 130, José Ignacio Álvarez, José María Fernández, Íñigo Navarro, Adrián Durán, Rafael Sirera (Eds.), ISBN: 978-2-35158-221-3, e-ISBN: 978-2-35158-222-0, 681-694.

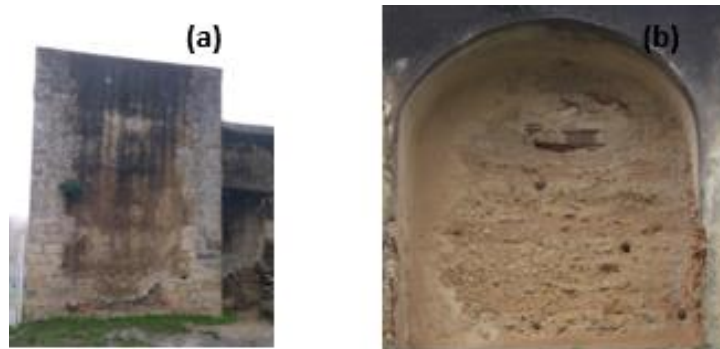
Figure 5 – Gil Vicente's School: (a) small tower with stone masonry corners and rammed earth and (b) rammed earth section of the Wall

The walls of the garden of Gil Vicente's School presents one of the most protected and preserved sections of the Fernandina Wall, with a well preserved section of about 50 m, with small towers and large walls. Sited on the eastern section of the Fernandina Wall (Figure 1 (4)), it was the only surveyed site visited in the East section. The building techniques used includes stone masonry, mainly in the small towers base and corners, as well as rammed earth in other areas of the small towers (Figure 5 (a)) and on a Wall section that could be observed (Figure 5 (b)). It was possible to induce that the rammed earth was air lime stabilized because white friable nodules could be easily observed on the rammed earth surface, dispersed within the earthen matrix. The stabilization of rammed earth with air lime was a common technique on Portuguese defensive structures like castles and fortresses [5]. The rammed earth section presented a very eroded render with lack of cohesion that was falling, exposing the rammed earth technique (Figure 5 (b)).

Two samples were extracted, one from the wall and another from the small tower. The observation of these samples confirms that they are built with rammed earth technique. Also, an intervention held in 2016 [6] in the construction of a car parking in the opposite side of this Wall section confirms this technique.

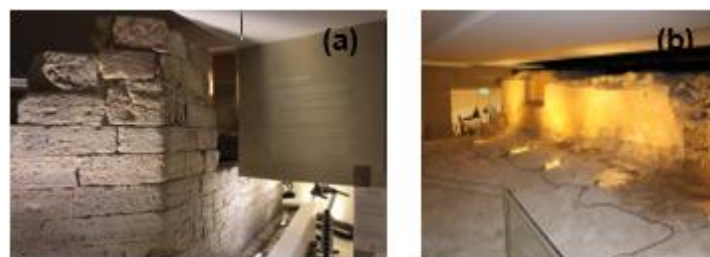
Figure 8 – Corpo Santo Hotel: (a) João Bretão Tower and (b) nucleus of the tower

According to Vieira da Silva [2], this part of the city is lacking in studies about the Fernandina Wall. Nevertheless, when Corpo Santo Hotel start being built, an archaeological and restoration campaign was performed and important data was collected [8-9], having the Hotel won an international prize for this preservation. This part of the Wall was built to protect attacks from pirate ships entering the Tagus river (Figure 1 (7)). Nowadays, the hotel offers a large room where remains of the João Bretão Tower and a section of the adjacent Wall are visible (Figure 8). Two core samples were extracted from the top of João Bretão Tower. These samples allowed to observe the top layers of the rubble stone masonry walls of the tower.

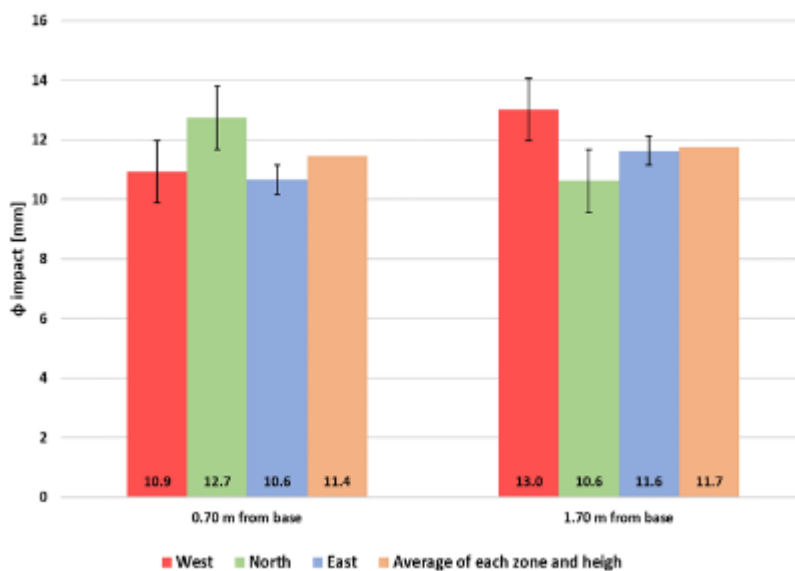
Figure 12 – Sphere impact results in Jogo da Pêla Tower

The values of diameter of the concavity resulting from the sphere impact test, using the Martinet-Baronnie equipment, can be observed in Figure 12. At Bragança Terraces Residence it was only possible to test the lime-stabilized rammed earth replica, 20 cm and 60 cm from the ground, obtained 14.6 mm and 13.8 mm respectively. These values, unlike to the results presented by [12], that reveals larger diameters, between 18-21 mm, and lower mechanical resistance. In [13] Veiga et al. analysed by the same methods the surface hardness of two panels of different renders and obtained a sphere impact diameter of 15 mm and 12 mm for hydraulic lime and white cement, respectively.
