# Decorative renders simulating stone of middle 20th century in the region of Lisbon

Maria do Rosário Veiga<sup>1</sup>, António Santos Silva<sup>2</sup>, Cláudia Martinho<sup>3</sup>, Paulina Faria<sup>4</sup>

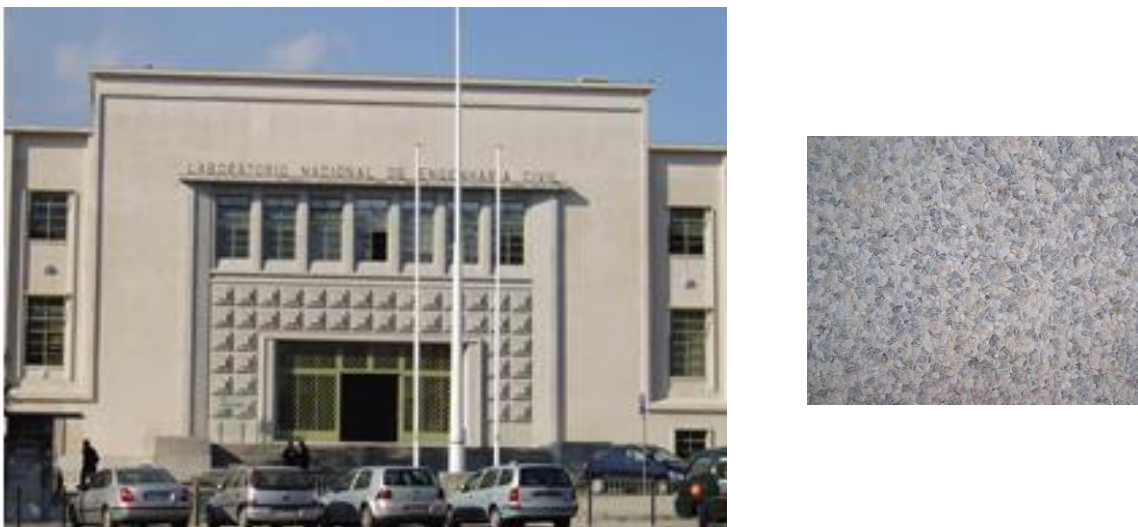
Figure 1 – Façade of LNEC main building covered with *marmorite* render: a) General view; b) Detail of *marmorite*

These *marmorite* renders were used both in public buildings of some importance, such as Lisbon University (1961) and National Laboratory for Civil Engineering – LNEC (1952) (Figure 1), and in housing urban buildings of the same period for medium and medium-high classes (Figures 2 and 3). They have also been used to retrofit older housing urban buildings, some for rent.

In Institutional buildings, neutral colours were used (combinations of grey and cream colours) (Figure 1), while in housing buildings several colours, such as red-pink, green and yellow, were adopted by adding inorganic pigments to the binder and choosing marble and limestone aggregates of matching colorations (Figures 2-3).

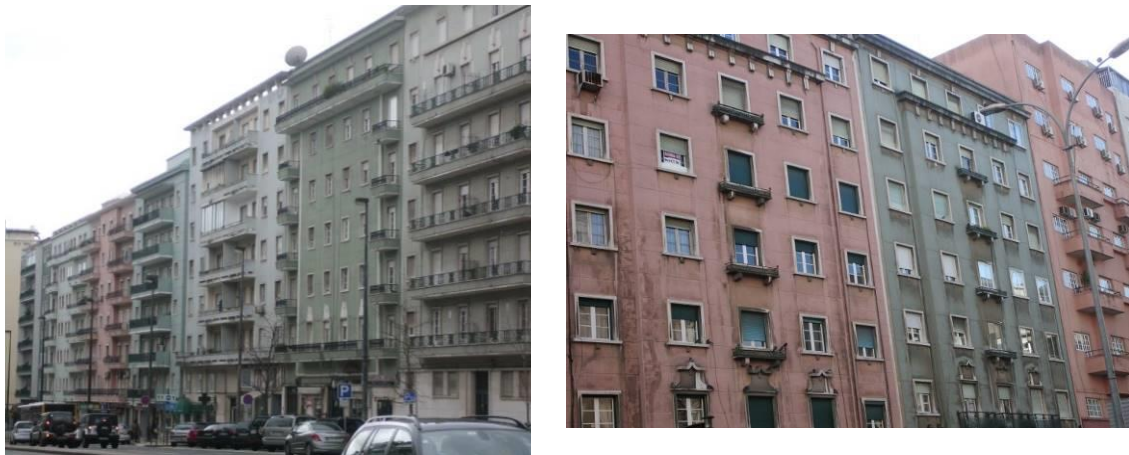
Figure 2 – Façades covered with colourful *marmorite* renders of Av. De Roma, Lisbon

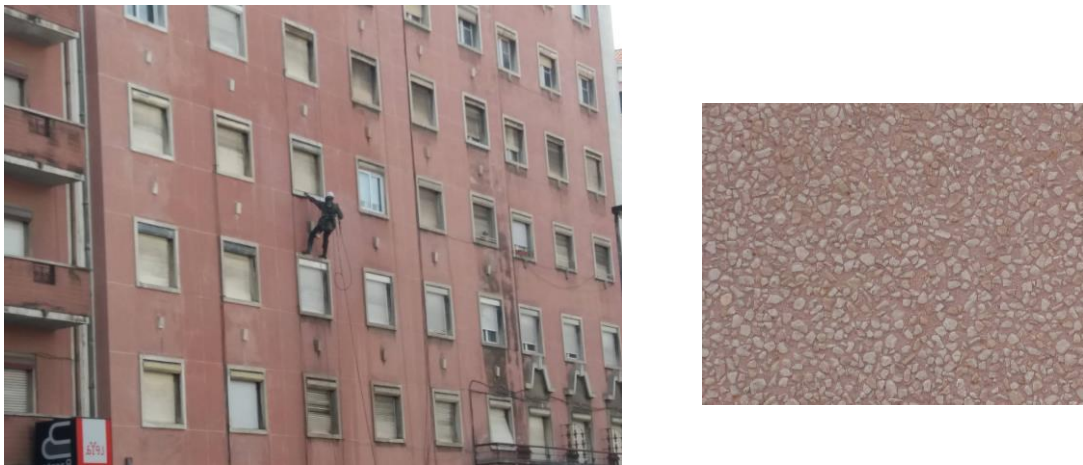
Figure 3 – Pink-red traditional *marmorite* render in Lisbon: a) General view during cleaning; b) Detail of red/pink *marmorite*

Being a very durable kind of render, after more than 5 decades, they show few anomalies, such as some cracks, stains and fungi and punctual erosion and lacunae (Figure 3).

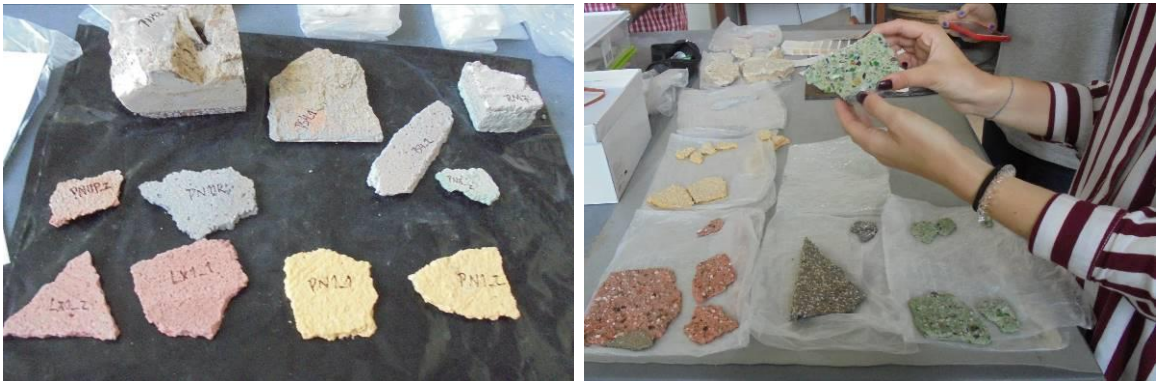
Figure 5. Samples of differently coloured *marmorites* collected

Samples of *marmorite* renders were collected in the districts of Lisbon, Santarém and Setúbal (within the region marked by the red circle in the map of Portugal mainland - Figure 4), in LNEC's main building, located in a heavy car and plane traffic, and in housing buildings mainly of the decades 1950-1960, with different colours. It should be noticed that the collection of samples was generally only allowed by the owners in the case of renders with anomalies and in limited quantity and dimensions. Such low quantities permitted chemical, mineralogical and microstructural tests, but in many cases were not enough for physical and mechanical testing (Figure 5).

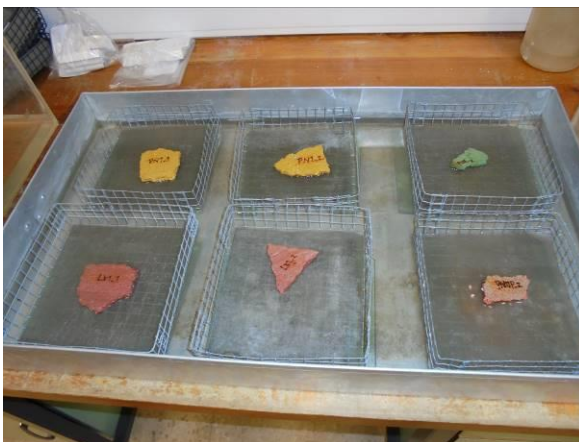
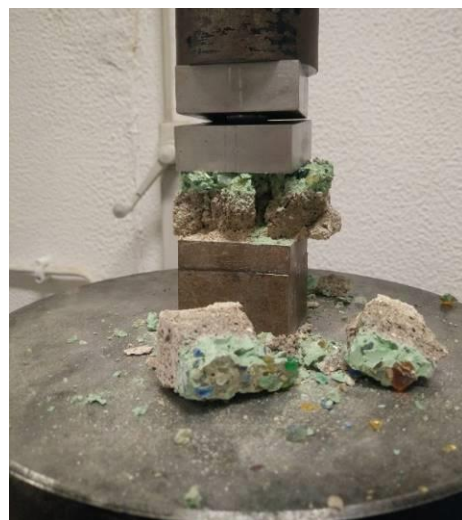
Figure 6. Physical and mechanical testing: a) Water absorption by capillarity; b) Compressive strength

- Open porosity by the method of hydrostatic weighing based on EN 1936 [9];
- Mercury intrusion porosimetry (only one case);
- Water absorption by capillarity by a method based on EN 15801 [10] and adapted for irregular samples [11] (Figure 6 a);
- Compressive strength using a method based on EN 1015-11 [12] and adapted for irregular samples [11] (Figure 6 b), using a Hoytom S.L., model HM-S equipment, with load cells of 200 kN and 2 kN.

A synthesis of the composition, together with the results of physical and mechanical characterization, are presented in table 4, for the samples now organized by district and not by colour, in order to investigate local influences. As referred before, only part of the samples could be tested for bulk density, porosity and water absorption by capillarity and only 3 could be subjected to the determination of compressive strength (Figure 6), due to size limitations.
