DURABILITY OF LIME BASED RENDERS: A REVIEW OF SOME DEGRADATION MECHANISMS AND ASSESSMENT TEST METHODS

In the present paper the degradation mechanisms leading to cracking, loss of adhesion or cohesion and stains formation are analysed based on literature, and a review of assessment test methods are carried out. Finally, the need for test improvement in this area is highlighted.

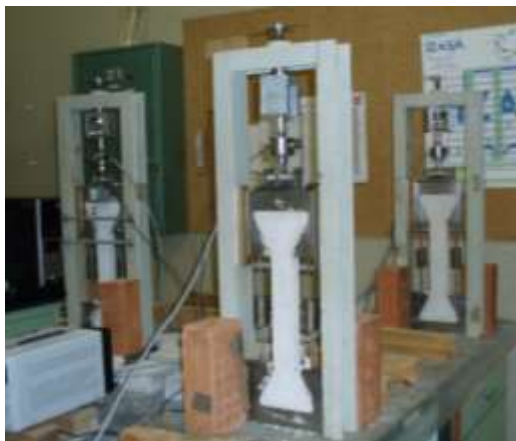
These tests are based on moulding a uniaxial specimen inside a device that allows blocking the deformation, and measurement of the force induced by restrained shrinkage [11,21,22,10,2] (Figure 1 a). Free shrinkage can be measured simultaneously in similar specimens. Some advantages of this type of method are: curves force-displacement and force-time can be drawn; restrained shrinkage can be compared with free shrinkage; parameters such as energy of fracture and maximum elongation at rupture load may be determined; due to the simple geometry of the device, the values obtained can be simply related to stress and strain to be obtained in-service. A drawback is that a very specific equipment is needed.

Figure 1 – Restrained shrinkage tests: a) Uniaxial test; b) Slab test

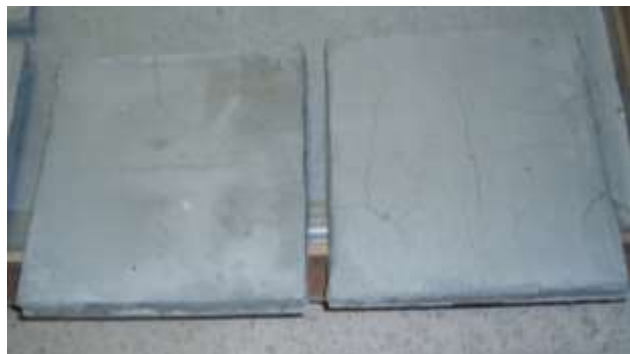
These methods [23,24,25] are based on the application of a mortar on a stiff substrate, such as a concrete slab, which simulates the wall that restrains shrinkage (Figure 1 b); the cracks formed are observed and several parameters are measured: time of opening of the first crack; pattern and area of cracking; number of cracks; maximum crack width, etc. These are the tests that better simulate the in-service conditions and they are easy to perform and do not need

complex equipment. They allow comparison between different materials, however, they are mainly qualitative, not permitting stress measurement.

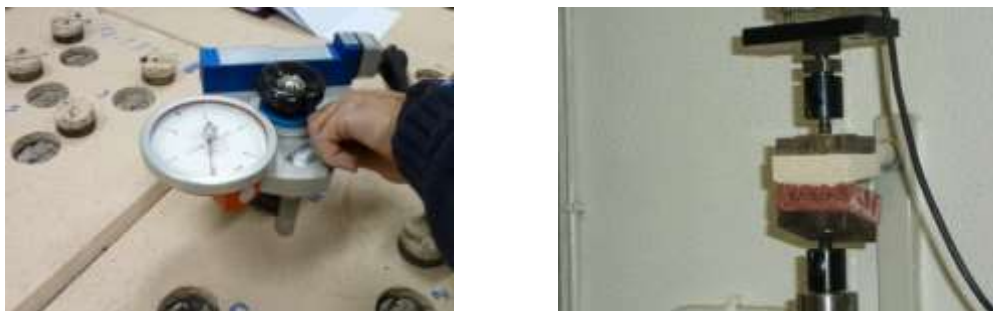
A method for determining the adhesion strength between mortar and substrate is described in EN1015-12 and is defined as the maximum tensile strength applied by a direct load perpendicular to the surface of the mortar on a substrate. The adhesive strength obtained is the quotient between the failure load and the test area. It is commonly known as pull-off method and is performed with a pull-off dynamometer specified also in several standards and Guides [28,29,30]. Pull-off is a widespread method (Figure 2 a), easy to perform. However, it has some drawbacks concerning air lime mortars: their tensile strength is very low, and as the test is based on the application of a tensile load, the obtained adhesion values are in the range 0.01-0.10 MPa [31,32], corresponding to applied forces of 20-100 N, which significantly reduce the precision of the method. In fact, pull-off devices commonly available with the best accuracy have capacity until 5000-6000 N, and low sensitivity to small variations of load. Additionally, the load application control is limited. Hence, the accuracy of results for low strength mortars is insufficient. A method based on a tensile load applied on a composite specimen substrate-mortar by a mechanical machine of higher precision and allowing adequate control of load application has been tested and results obtained proved to be more sensitive [31,32] (Figure 2 b). However, this method is not applicable on site.

Figure 2 Adhesion with a) pull-off apparatus and b) tensile machine
