DB-HERITAGE: A database of mortars composition and characteristics

Abstract

SANTOS SILVA A., GIOLLO R., CORREIA M.J., VEIGA M.R., FARIA P. (2019), DB-HERITAGE: A database of mortars composition and characteristics. *HMC2019 - 5th Historic Mortars Conference*, 19-21 June 2019, Pamplona. RILEM Proceedings PRO 130, José Ignacio Álvarez, José María Fernández, Íñigo Navarro, Adrián Durán, Rafael Sirera (Eds.), ISBN: 978-2-35158-221-3, e-ISBN: 978-2-35158-222-0, 516-528. https://www.rilem.net/publication/publication/494?id_papier=11341

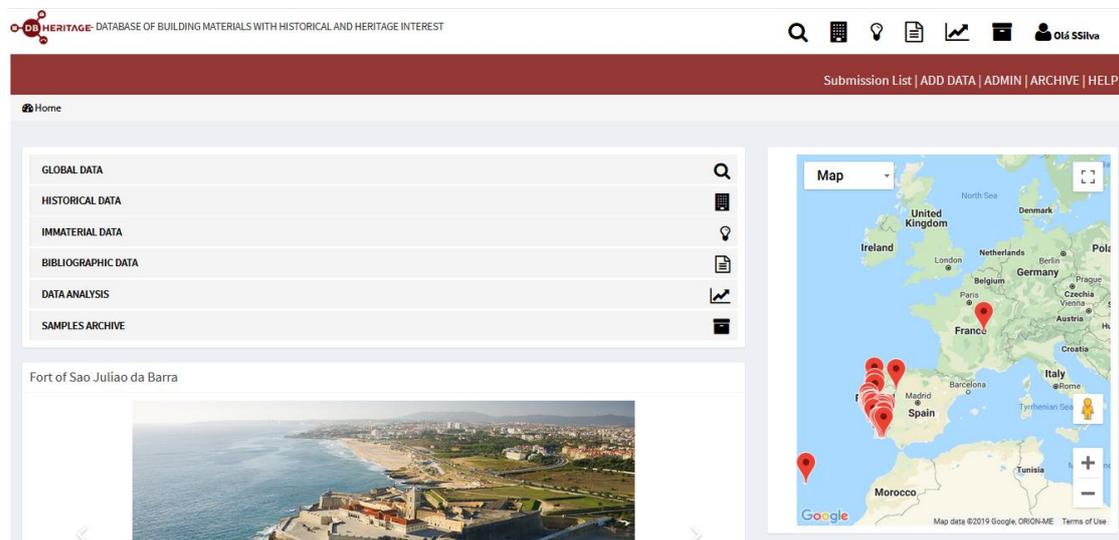
Figure 1. Data query options in DB-HERITAGE database; in the map it is possible to see the location of the available case studies

The user of the database can select specific monuments/case studies related data (e.g. generic information, historical events, material characterization) and access it according to different visualization options, including material type (e.g. mortar, stone, wood, etc.), and structure type (e.g. church, fort, palace, etc.) with option on filtering by case study designation (Figure 1).

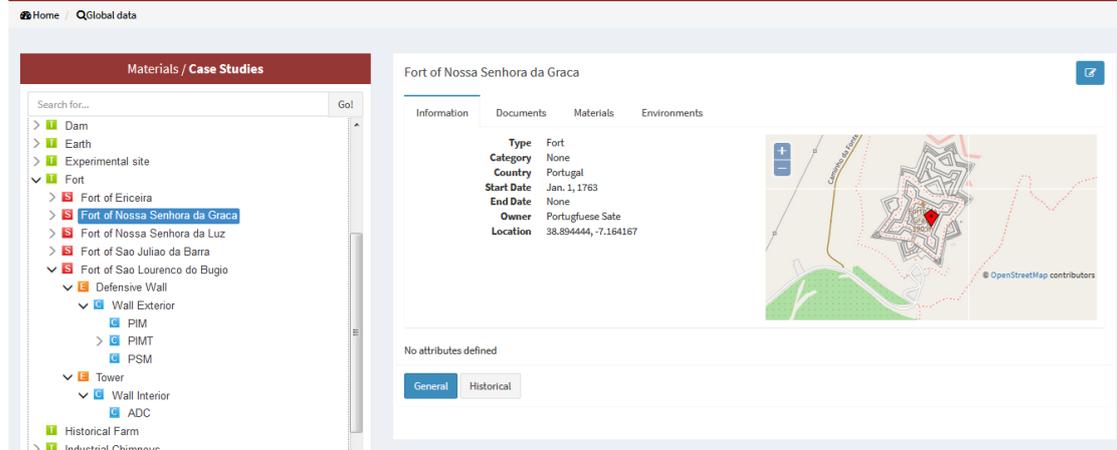
Figure 2. Example of a hierarchical schematization of a case study

The data for a given monument is hierarchically grouped according to its elements (e.g. tower, bastion, etc.) and components (e.g. interior wall, floor, etc.) - Figure 2.

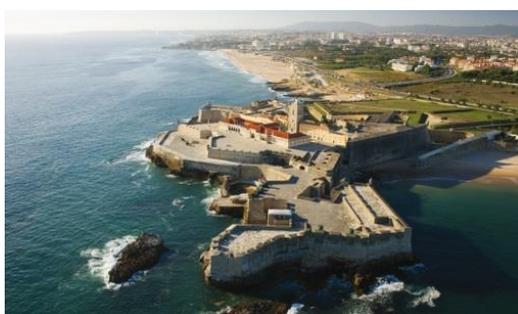
The Fort of São Julião da Barra (SJB), in Figure 3, is located on the right bank of the Tagus River, at the Point of São Gião. It is an example of military baroque architecture being

the most complete military defense complex constructed to defend the port of Lisbon. It was operational in 1580 but its construction took nearly a century to complete. Throughout Spanish dominion (1580–1640) it was used as a state prison. Later, in 1650, works were undertaken to increase the power of the defensive landside. In the early 19th century, during the French occupation, Napoleon military forces were installed in São Julião da Barra to combat the English fleet that blocked the entrance of the Tagus river. The latest military action involving the fortress took place in the context of the 1831 Portuguese civil wars. Two samples, taken by the Portuguese Directorate-General for Cultural Heritage, one from the filling mortar (SBJ-J) and another from a rendering mortar (SJB-R), both from south wall [4], were characterized in terms of material constituents.

Figure 3. Aerial view of Fort of São Julião da Barra

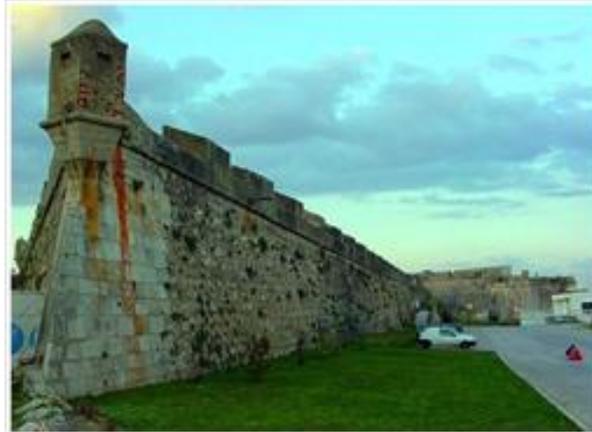
Figure 4. Bulwark of Fortress Nossa Senhora da Luz

The Fortress of Nossa Senhora da Luz (NSL), in Figure 4, is currently classified as a building of public interest, being located on the right bank of Tagus River, in Cascais Municipality. It is considered to be representative of the architecture transition from the medieval castle model to the bulwark fortress [5]. Built in 1580, in the Philippine period, it includes an earlier structure, the *Santo António Tower*, also known as *Joanina Tower*, ordered to be built by D. João II, in 1488, later transformed into a fortress with three Bastions, at the end of the 16th century, to reinforce the defense of the Bay of Cascais, constantly threatened by the English navy [6,7].

This fortress has a trace considered to be uncommon in Portuguese military architecture, a triangular plant with an interior courtyard that provides the connection between its three bastions and from where the stairs to the Joanina Tower and cisterns start. The two bastions face the sea from obtuse angles, while the third one forms an acute angle [6,7]. Due to the damages imposed by the Lisbon earthquake at 1755, part of the fortress and of the Joanina Tower have suffered important architectural transformations [5,6,7]. Currently, the fortress belongs to Cascais Municipality, and undergoes a process of recovery and revitalization with the purpose of implementing a museum space [7]. In 2012 a study was carried out on the characterization of the exterior and interior plasters of the fortress, aiming: (i) the in-situ evaluation of the state of conservation of the mortars; (ii) extraction of samples of the external and internal renders (labelled as NSL) for laboratory characterization.

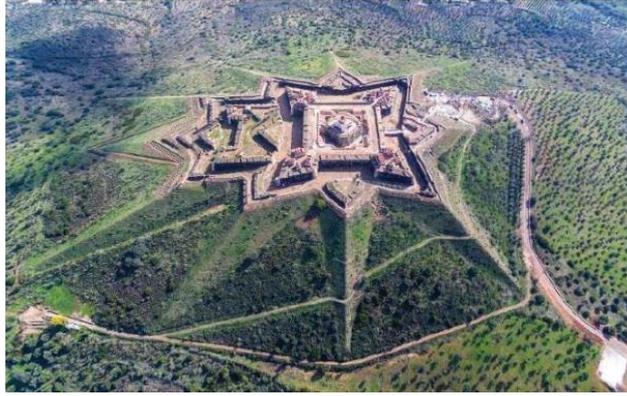
The Fort of Nossa Senhora da Graça (NSG), also known as Fort Count of Lippe (Figure 5), classified as National Heritage Site in 2010, and World Heritage Site by UNESCO in 2012, located in a mountain in the north of the town of Elvas, was built in the late 18th century ordered by King Joseph I of Portugal and by his minister, the Marquis of Pombal [8].

It is a masterwork of the 18th century military architecture, and is considered one of the greatest symbols of the bulwark fortresses of the world. The central structure is a 150 meters side quadrangle with pentagonal bastions at corners. Four ravelins cover the curtain wall, one of which constitutes the monumental entry. The central part of the bastioned structure features an octagonal stronghold with two floors and a parapet with gun ports. The fort's octagonal tower has two vaulted floors. The first floor features a cross plant and includes a chapel in one of the cross's arms. The second floor is divided in several compartments including gun ports, kitchens and wards. Below the stronghold, carved into the rock, there is a cistern. The stronghold is surmounted by de Governor's House, also divided in two floors. In the external side, the structure is completed by a hornwork, a fifth ravelin and a wide dry moat [8,9].

Figure 5. Aerial view of Fort of Nossa Senhora da Graça [10]

As part of nomination by UNESCO, a conservation and restoration plan was implemented in 2015, involving a detailed characterization of materials used on fort's construction. For this, several render samples (named NSG) were collected and tested in laboratory. The conservation and restoration works of mortars were carried out with compatible repair materials, selected according to the physical-chemical characterization study and their degradation state [8].
