Ofir spit (Portugal): an assessment of geotubes performance in coastal protection

ABSTRACT: The Ofir spit is located at the estuary of Cavado River (NW coast of Portugal), and is the natural protection of Esposende city, ensuring also the navigability of the river and preventing from the maritime invasion of its estuary or the flooding of the riverine part of that city. It has been subjected to the actions of nature, especially from the Atlantic Ocean, known for its energetic regime and, more recently, those of human activities. Considering that, in Portugal, the use of geosynthetics on coastal protection is not yet a usual solution, it is relevant to investigate it, especially in this case of high-energy wave agitation. The paper presents a summary on the interventions conducted to the sandbank along time, it refers also the solution implemented as well as the monitoring campaign conducted after December 2015, discussing its results and the viability of the structure itself as a permanent solution.

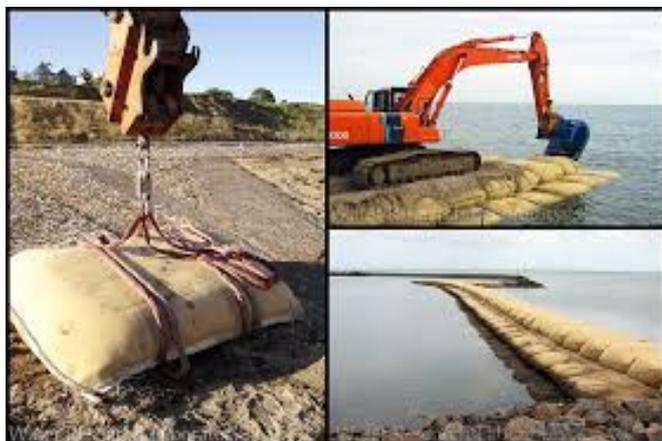
Figure 2. Placing of a geobag (Morais, 2010)

Geobags are geosynthetic elements of large dimensions and filled usually with sandy material. Normally are customized to meet the project's requirements and installation, being provided in various forms and dimensions - Figure 2.

The filling is held in a place near the structure, by mechanical means or pumping, and are further positioned by equipment that allow its lifting in what will be its final position that can either be on the surface or submerged, at any depth.

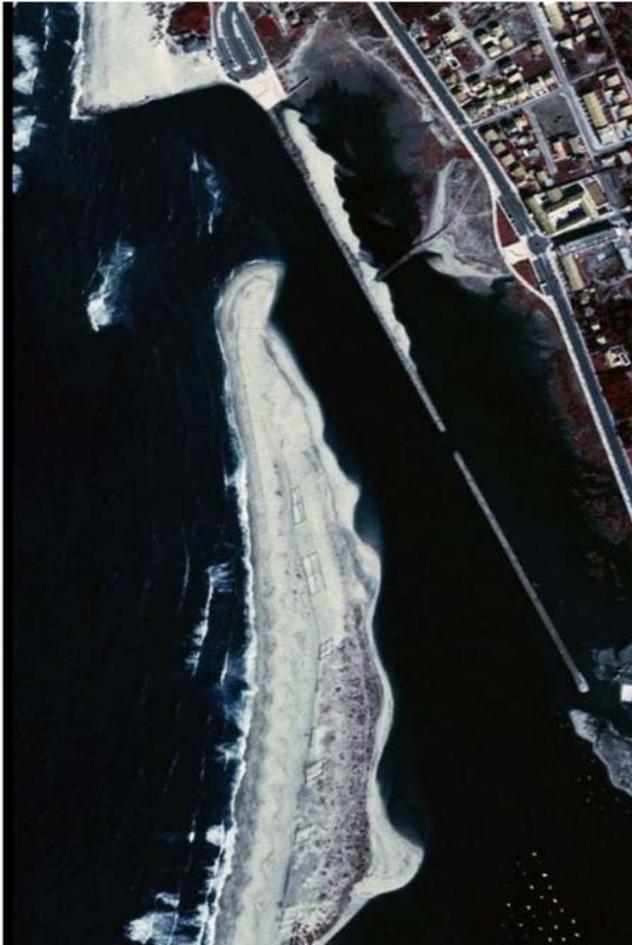
Figure 3. General view of the spit in 1995 after the artificial sand nourishment of 1994 (Polis Litoral Norte, 2013)

Figure 3 shows the results after the first nourishment and before the first maritime winter.

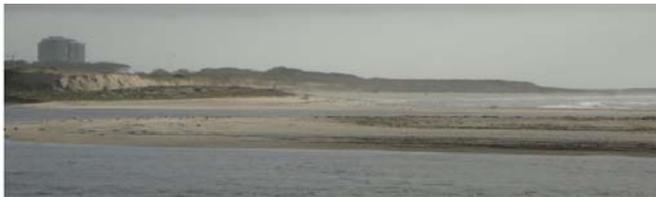
Figure 4. The spit along the ocean, after a storm in January 2013; view to south (Polis Litoral Norte, 2013)

After an important storm in January 2013, there was a significant alteration on the spit - Figure 4, with its head separated from the main body and the river mouth segmented in two.

Its weaknesses lead already to a rupture and the need of artificial nourishment at its northern tip.

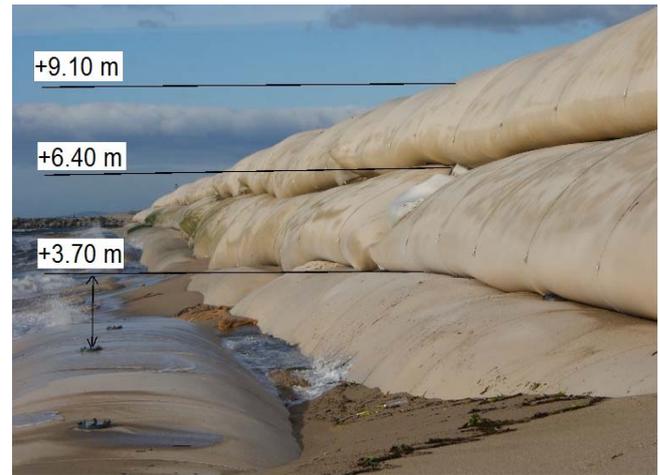
Figure 8. Overview to north along the ocean of the staggered geotubes

The construction work begun in June 2015 and ended November 2015 – Figure 8.

In the project, it was also determined that the bottom level should have two rows of geotubes, at the same level, on the oceanside – Figure 6. The ground observation determined that the external row of geotubes is located at a lower level than the other one - Figure 8. This configuration was not studied, as it was not the one designed.

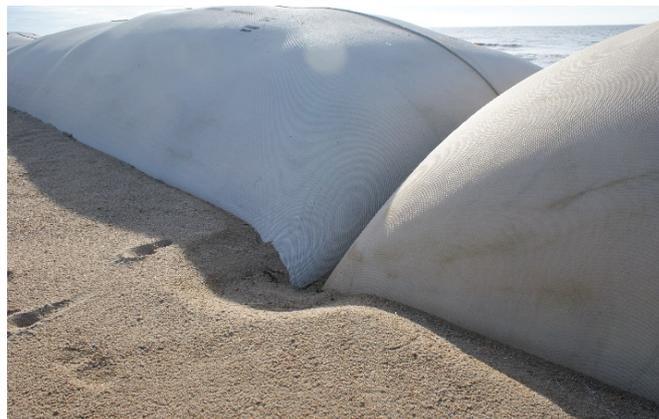
Figure 9. Evidence, at the beginning of 2016, of the hydraulic fill erosion after its overtopping by the sea; view to west

Although the geotubes were planned to protect an existing dune, which was in fact what the spit originally was, an artificial nourishment was made and an embankment was hydraulically filled in place of the dune itself. Furthermore, its overtopping was inevitable considering the height of the crowning postulated on the project - a landscape requirement. Indeed it occurred and the erosion was relevant – Figure 9.

Nevertheless, this type of protective structure and especially since it is located under the influence of the North Atlantic, will always require a rehabilitation intervention after winter season, namely to cover it with a protective cap of sand before the next winter.

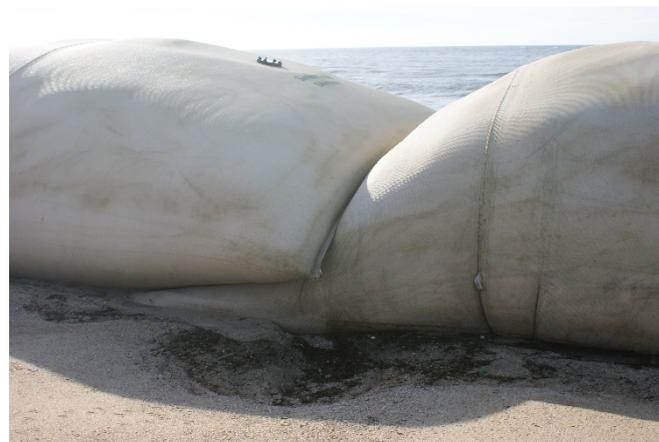
Figure 11. Detail of the overlapping of geotubes

The seams, which were made in factory, must overlap and fold - Figure 10 e 11. The extremities of each geotube should overlap the other one on 1.5m.

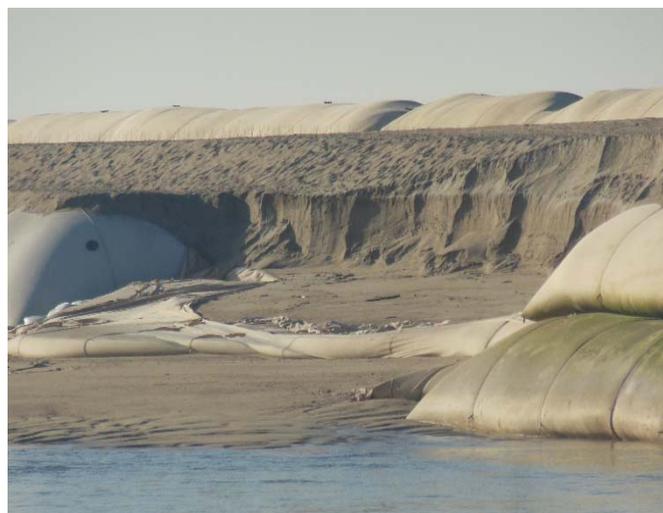
Figure 13. Riverside view of one of the geotubes (50 m long) that ruptured

In the first inspections, it was noted that the Atlantic Ocean overtopped the structure, but the hydraulic fill confined between the rows of geotubes remained mainly intact - Figures 12 and 13.

There were some geotubes with the seams disjointed on the top - Figure 13.

There was actually one geotube, on the riverside, which ruptured to the extent of emptiness - Figure 13. The rupture was first noticed after an important storm. The causes on the rupture of this geotube are inconclusive, although suspicions fall in either vandalism acts or else may be some sharp debris transported by the river - a tree branch perhaps.

At the riverside, once the sand covering was removed, the geotubes are exposed and accessible to vandalism. Additionally, they become exposed to anything the river brings to its mouth during floods.
