Fernandina old Wall of Lisbon – Characterization towards its preservation

Leandro Gomes¹, Paulina Faria², Vitor Silva¹, António Santos Silva³

GOMES L., FARIA P., SILVA V., SANTOS SILVA A. (2019), Fernandina old Wall of Lisbon – Characterization towards its preservation. HMC2019 - 5th Historic Mortars Conference, 19-21 June 2019, Pamplona. RILEM Proceedings PRO 130, José Ignacio Álvarez, José María Fernández, Íñigo Navarro, Adrián Durán, Rafael Sirera (Eds.), ISBN: 978-2-35158-221-3, e-ISBN: 978-2-35158-222-0, 681-694.

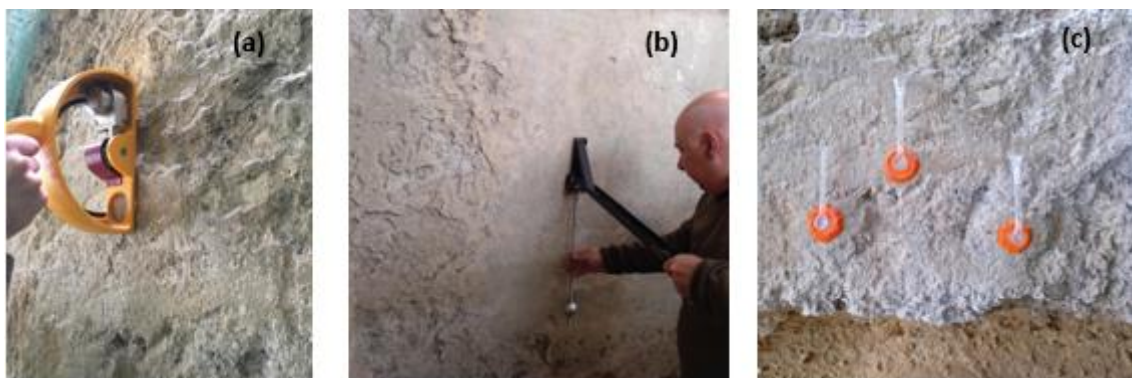
Figure 9 – *In situ* tests: (a) Pendular sclerometer in Bragança Terraces Residence wall section facing south; (b) Sphere impact test at a wall facing East inside Jogo da Pêla Tower and (c) Karsten tubes test at a wall section facing East at Bragança Terraces Residence
