# The Early Modern Belinho Ship (Esposende, Portugal): a First Report

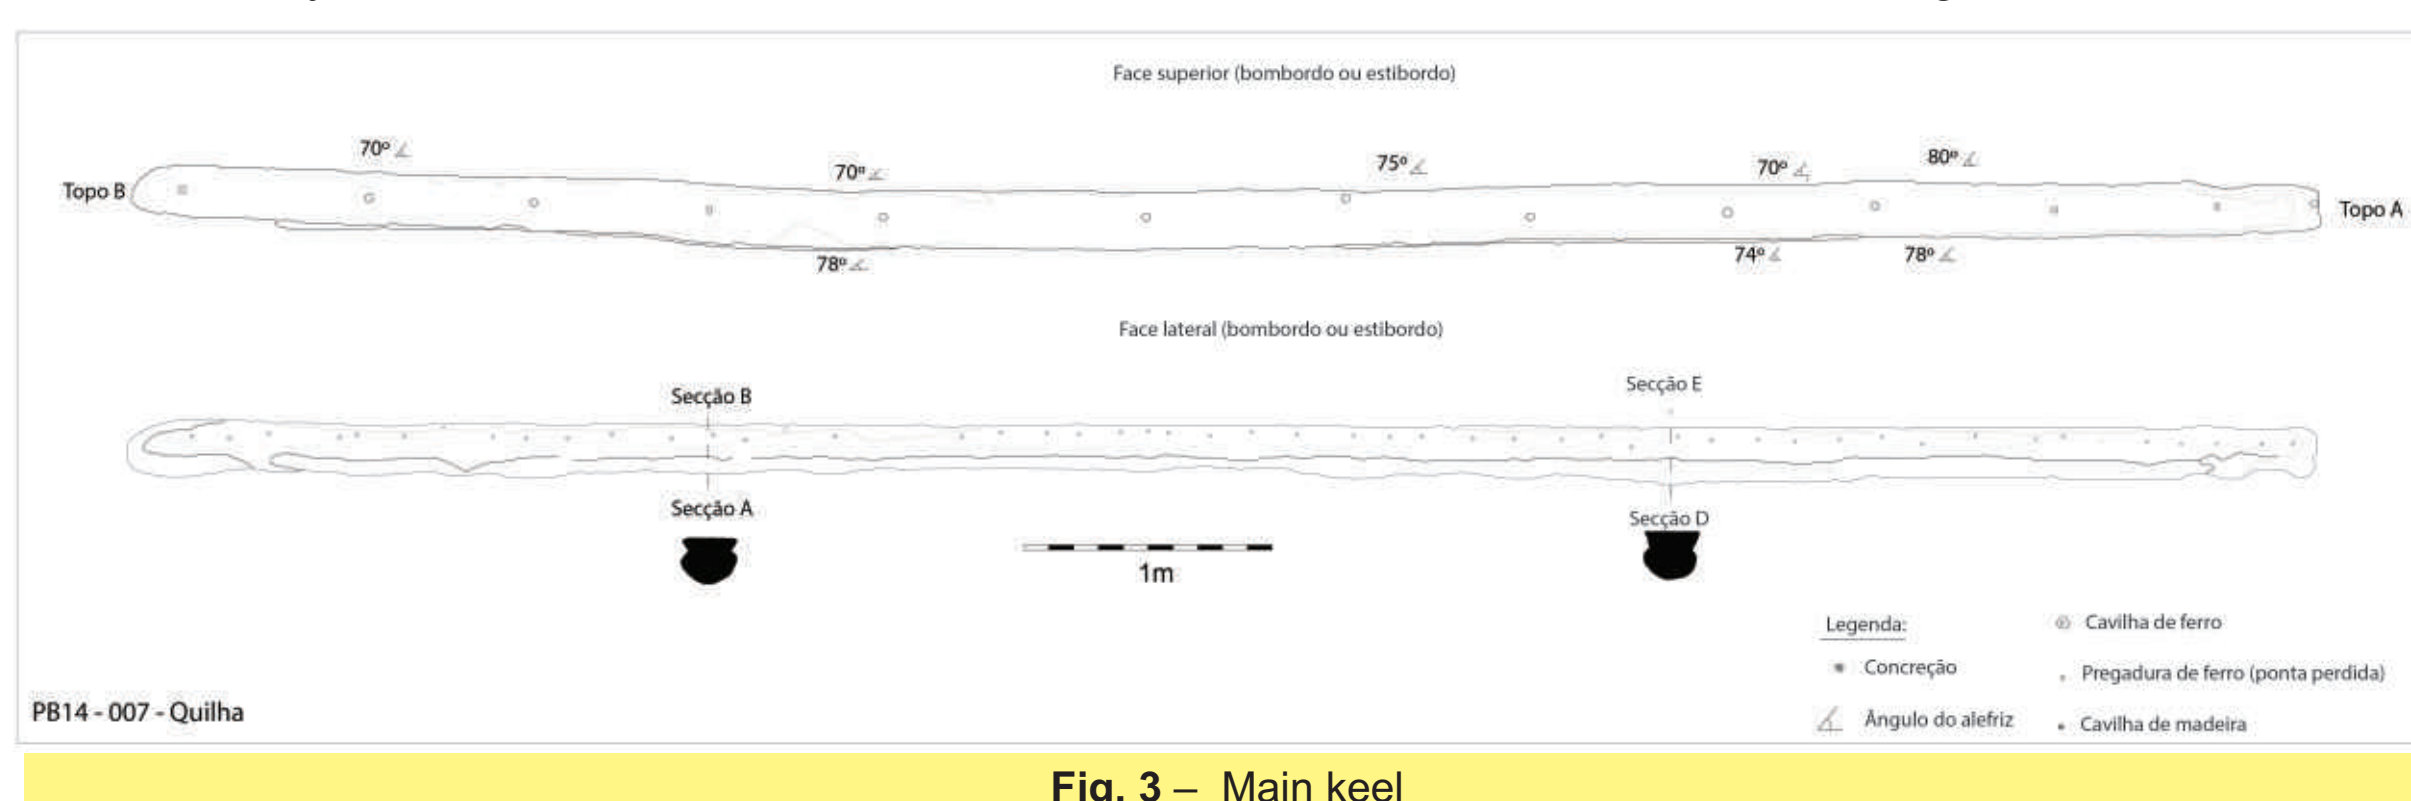
Fig. 3 – Main keel

One of the most interesting remains is a section of the keel (PB14-007), measuring 24.5 to 25 cm sided dimension and about 19/19.5 cm moulded dimension. The section is incomplete at both ends and has all surfaces eroded. Its construction incorporates the original shape of the tree at the lower face, where we can observe the sapwood, having only been carved on the sides for the rabbet and at the upper face for the floor timbers.

The rabbet runs along the keel but the bad preservation condition, doesn't allow to notice significant changes in the angle in relation to the upper face, suggesting that the garboards should also be carved.

There are no traces of fastenings of the floor timbers to the keel, with the exception of several iron bolts, which passed through the top to the bottom, where they were embedded in round countersinks. However, the rabbet shows a large amount of iron bolts, used for

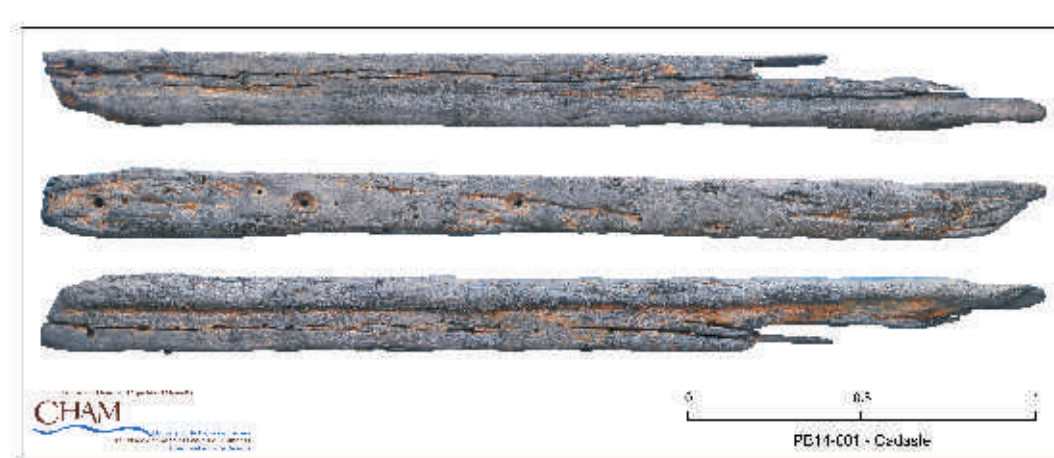
Fig. 4 – Sternpost

PB14-001 is probably part of the sternpost. It measures 2.90 m long with a 20 cm square section. In the aft end, small depressions with 7 cm wide were observed, probably to attach rudder fittings. It shows round iron bolts with 2.8 cm diameter, embedded in a countersink with 7.5 cm diameter, related to its attachment to the frames. On the outer surface it has nails with quadrangular section, with around 1 cm, used to join a filling piece. This surface has also small holes, most likely an evidence of nails used for fastening lead sheets.

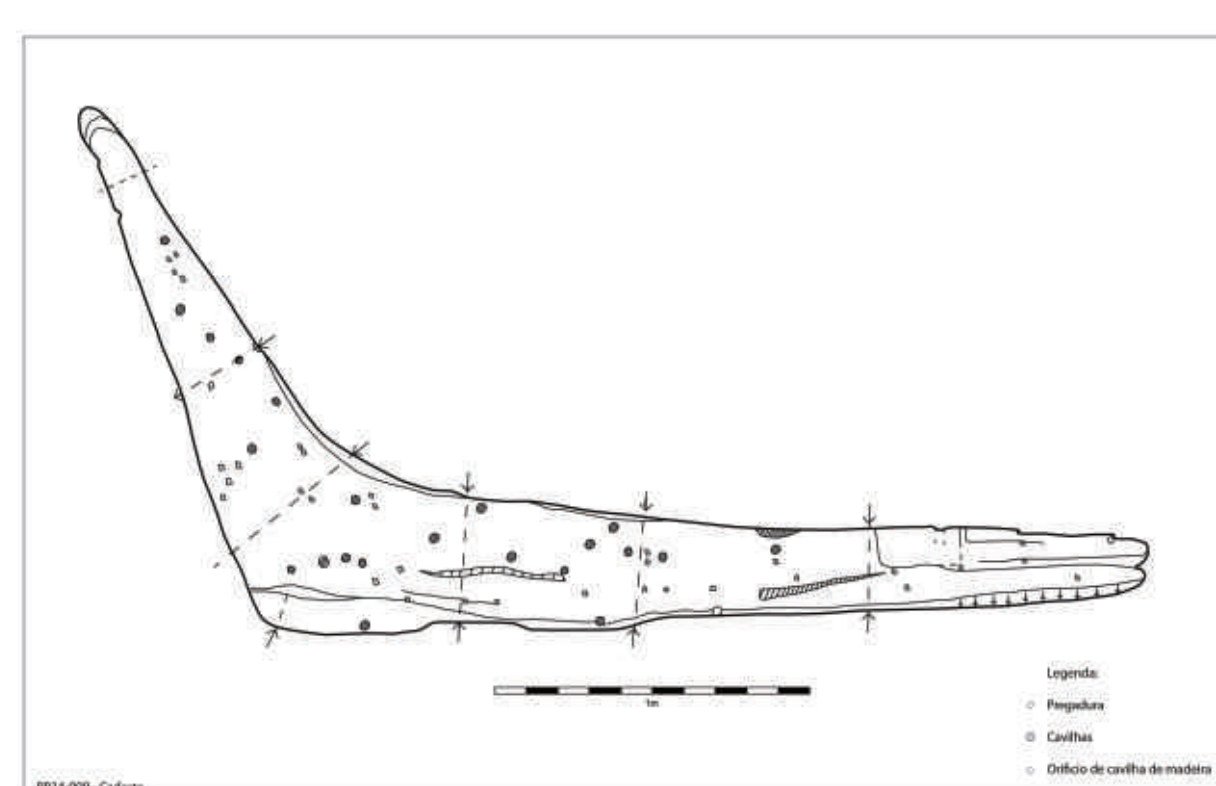
Fig. 5 – Sternpost knee

PB14-009 is probably the sternpost knee. It measures 3.6 m in length and has a trapezoidal section, wider in the top. The width develops from 21.5 cm, at the forward end, to 23.5 cm of maximum width in the curve and 21 cm in the upper end. The width of the lower surface develops from 16.5 cm, in the forward end, to 17.5 cm in the aft end.

This piece was connected in both ends, possibly to a heel and to the sternpost, with round iron bolts with 2.7 /2.9 cm, embedded in countersinks between 6.2 and 4.2 cm width.

In the edge between the upper and lateral surfaces there is a mortise, possibly for fitting a Y-shaped floor timber or crotch, with 26 cm long, 14 cm deep and 4.7 cm wide.

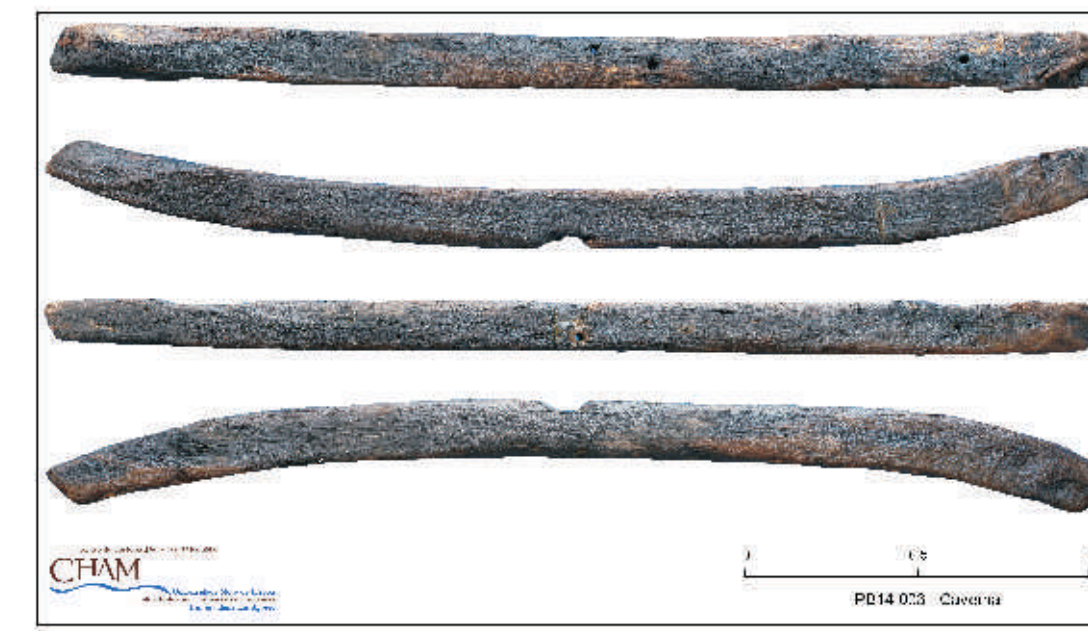
Fig. 6 – Floor timber PB14-003

A complete floor timber (PB14-003), measuring 3.11 m long, around 15.5 to 16.5 cm sided and 16.5 to 18 cm moulded dimensions, is particularly interesting because preserves the dovetail mortise used to connect the futtock. It is very eroded, measuring 24 cm in the outboard edge and 16 cm at the inboard edge. This assembly is also fastened by treenails and two or three iron nails.

Three floor timbers are certainly from the central section of the ship (PB14-003, PB14-010 and PB14-011). All had an eroded limber passage, 6 cm wide and 4 cm high, and shows remains of treenails and iron nails used to fasten the futtocks.

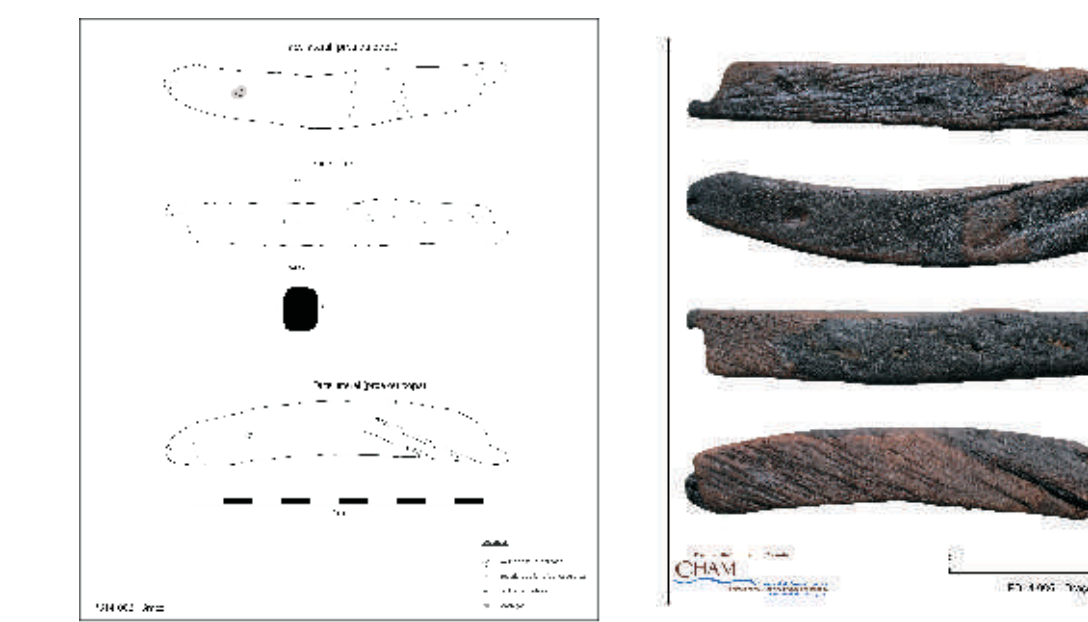
Fig. 7 – Futtock PB14-006

A similar pattern was recorded on a small futtock fragment (PB14-006), incomplete, 16 cm sided and 17.5 to 13.5 cm moulded. It was fastened to the floor timber with a dovetail mortise about 1.5 cm deep, strengthened with an iron nail and treenail.

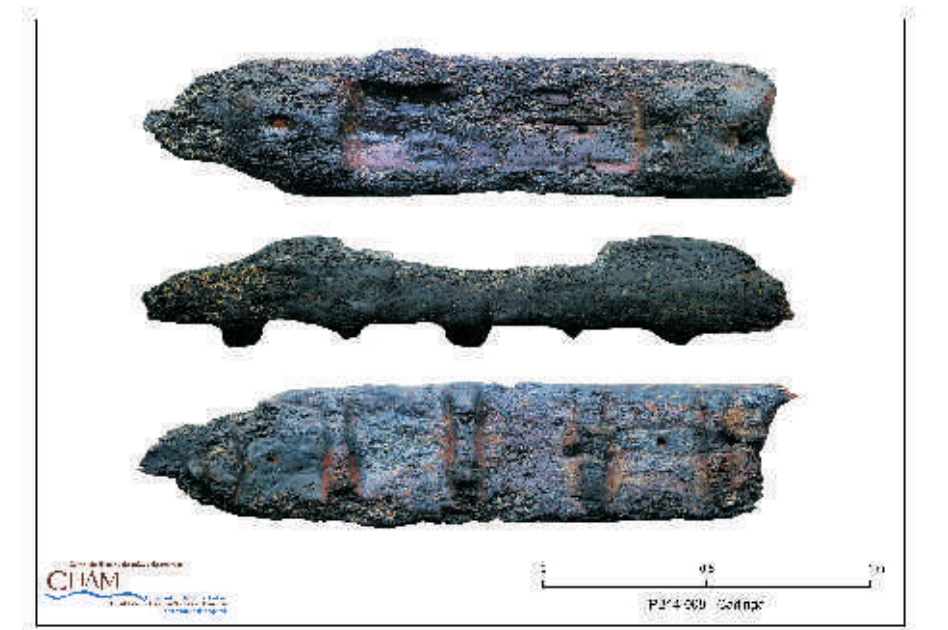
Fig. 8 – Mast step

PB14-008 is a very eroded mast step, 2 m long but incomplete in the both extremities. The maximum width or sided dimension ranges between 27 cm, before expanding to the mast step, and 42 cm. The moulded dimension is 21 cm. The lower face was notched to fit over the floor timbers. The mast step was fastened with round iron bolts with 2.9 cm diameter, similar to the ones recorded in the keel.

The mortise that received the mast, very eroded, has 83 cm long, by 21 cm wide and 11 cm deep. It presents a circular hole, with 3.5 to 4 cm diameter, which might have been used for water drainage, since it doesn't seem to correspond

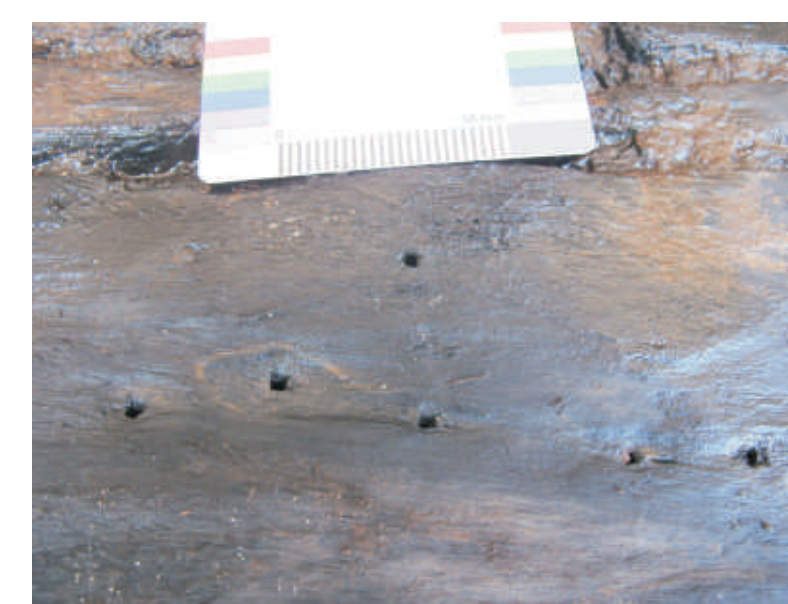
Fig. 10 – Detail of the lower face of the keel: hole of a ringed iron bolt

Iron nails, bolts and treenails were used. Iron appears in the shape of quadrangular section nails used to fasten futtocks to the floor timbers, and the planks and the footwales to the frames. In iron were also produced bolts with 3 cm of diameter, possibly all ringed, which would fasten the keelson to the keel, going through the floor timbers, or the sternpost to the frames. There are also evidences of small nails that fastened lead sheets to the hull planking that protected the ship below the waterline. The treenails measured 2.7 to 2.8 cm diameter, and were used to fasten the hull planking to the frames and between the futtocks and the floor timbers.
