Vernacular Caramel's Adobe Masonry Dwellings - Material Characterization

In Pinhal Novo, Palmela, and neighboring municipalities, southern Lisbon region, there are a great number of small adobe masonry dwellings, made in the first half of the 20th century. The vernacular dwellings were constructed by families that came from the north/center region of Portugal to work at the local manors, and were called Caramel's. Adobe samples from three of these dwellings were collected in Pinhal Novo and Moita, and tested for particle size distribution, X-ray diffraction, color, bulk density, ultrasonic pulse velocity, thermal conductivity, dry abrasion, flexural and compressive strength, capillary absorption and drying. It was possible to conclude that the adobe was not chemically stabilized and had no vegetable fibers. Average values for the adobe properties were defined and results were analyzed, revealing comparable to unstabilised adobe and even to lime stabilized adobe from other regions. The data on Caramel's adobe can support the design of interventions to preserve at least some of these Caramel's vernacular dwellings.

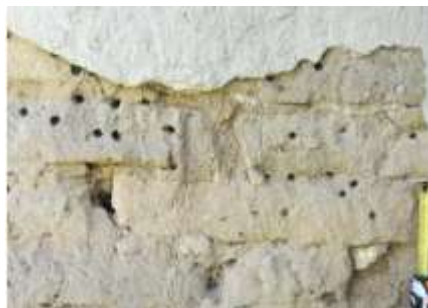
Figure 1. Exterior façade of a Caramel dwelling in Pinhal Novo, showing lack of protective render and degradation of adobe, by weathering and insects, showing the importance of a protective render.

In the south of river Tagus, south of Lisbon, Pinhal Novo parish, Palmela municipality, and neighboring municipalities, such as Moita, there are a great number of small adobe masonry dwellings, made in the first half of the 20th century. These vernacular dwellings were constructed by families that came from the north/center of Portugal to work at the manors located in this region (Fernandes, 2008; Sampaio, Oliveira and Faria, 2017) These people were called Caramel's and associated with the Caramel culture. Therefore, the dwellings were named Caramel's dwellings. These dwellings are mainly composed by load bearing adobe masonry walls and a simple wooden roof structure, covered with ceramic tiles. The load bearing adobe walls were originally rendered and plastered. Most of these constructions are currently abandoned, needing major repair (Figure 1).

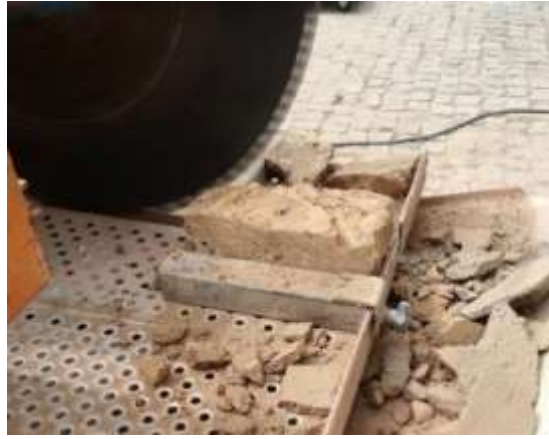
Figure 3. Adobe samples cutting for specimen preparation.

The cutting was performed with the objective of creating regular size test specimens for some laboratorial testing.

For instance, from the original sample 17015_d (Table 2) a prismatic specimen of 0.10 m x 0.15 m x 0.30 m was cut out of the original sample and is designated by C_4 (Table 3), as well as sample C_0.3 with 0.10 m x 0.15 m x 0.15 m. From the disaggregated material, testing for material particle size distribution was performed, expedite sedimentation and X-ray diffraction. Samples and specimens obtained from each case study and used for each test are presented in Table 3, as well as the test standards or guidelines that were used.

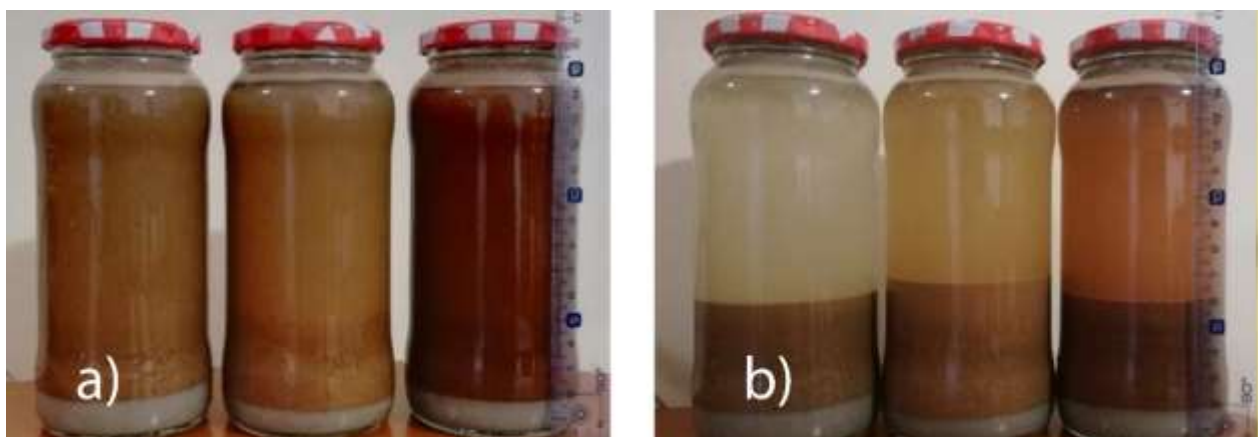
After removing very coarse (thicker than sand) aggregates of a sample, it was placed material in a transparent glass jar with a straight base (that was previously made with a cement paste layer), mixed with water and let the particles to decant, so that the proportions of sand, silt and clay (that decant at different speeds and, therefore, form separate layers) can be determined: $\frac{1}{4}$ of the bottle capacity was filled with earth (125-135 g for each case study), $\frac{3}{4}$ with potable water. The bottle was shaken vigorously for 1 to 2 minutes and left to rest for an hour. One hour later it was shaken again. After some time, thick and thin sand, as well as silt were already visible. After 24 hours, clay particles could also be distinguished (Figure 4).

Figure 4. Expedited sedimentation test: a) start of the test; b) after 50 minutes.

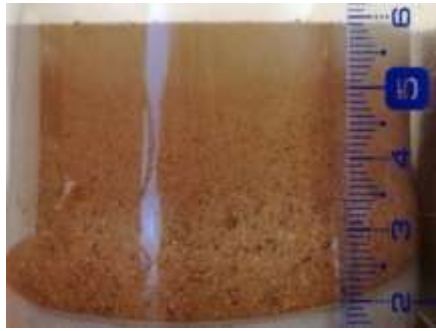
Results were obtained by analysing at the 24 h mark the differences in height of the various layers and transforming them into percentages (Figure 5).

Figure 5. Assessment of sedimentation test results after 24 h of case study 218.

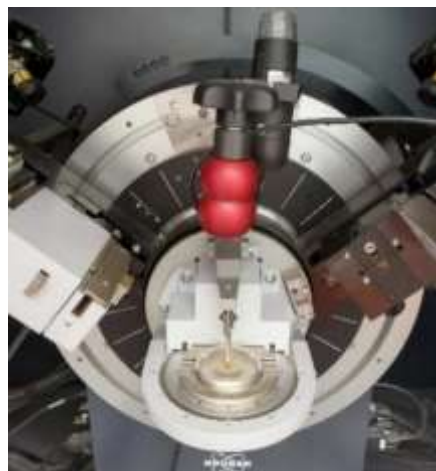
After this process, 2 g specimens were thus analyzed in Bruker D8 Discover diffractometer (Figure 6), equipped with a 1D lynxeye detector and using a Cu K α radiation source (40 kV, 40 mA).

Figure 6. X-ray diffractometer “Bruker™ D8 Discover”

The diffractograms were registered between 3° and 75°, 2 θ , with an increment of 0.05° 2 θ s⁻¹. The identification of the materials was performed using software DIFFRAC.SUITE EVA and the database PDF- 2. The semi-quantitative abundance of minerals in the samples was obtained through the method of Reference Intensity Ratio (RIR) after Hubbard et al, 1976.

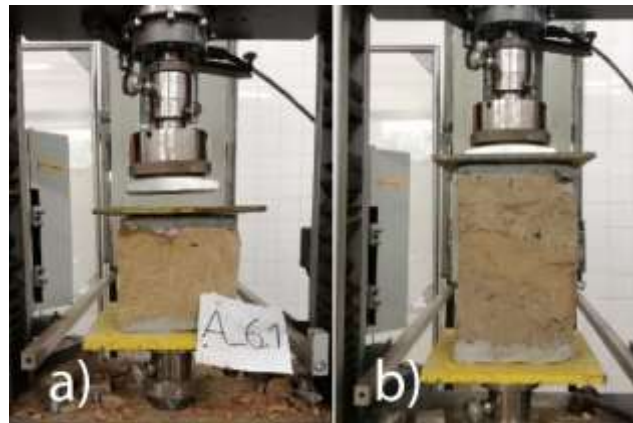
Figure 7. Compression test equipment for: simple specimens (a) and overlapped specimens with bedding mortar (b) showing the specimens top and bottom capping.

The same Zwick-Rowell Z050 was used for the compressive tests. These were performed by two different test procedures: the testing of simple axial compression of adobe samples (Figure 7a) and the testing of specimens composed by two portions of adobe overlaid with a bedding mortar (Figure 7b). For both cases, due to the presence of aggregates of elevated dimensions, the choice was not to utilize the cubic specimens of 0.10 m x 0.10 m x 0.10 m, as indicated on the NTE E.080 (2017),

but larger and more representative samples, maintaining the original thickness of the adobe and making parallelepipeds with 0.15 m x 0.15 m x height of the adobe, that was 0.10 m for all the tested adobe (Table 3). However, this choice resulted on having adobe specimens for simple compressive test with height-to-width ratio of 0.7, that is lower than 1 and can, in turn, result to increased platen restrain effects that have to be taken in consideration when analyzing the results. This was also the motivation for, as complement of the simple compressive tests, performing also compressive test but with two overlapped adobe specimens with bedding mortar.

For the specimens composed by overlapped adobe samples, a mortar was made with the same earth of each case study, and placed in between the two samples, as a bedding mortar, in a similar way to Adorni, Coisson and Ferreti (2013). As the bedding mortars were applied with 1-2 cm thick, the coarser particles of the earthen materials not compatible with that thickness were previously removed. The water was added so the earth mortars present a workability considered adequate for bedding mortars. Immediately after its preparation, a fresh sample of each earth mortar was weighted and placed in an oven to dry. The water content was determined by the difference in weight of fresh mortars samples and the same samples after oven dried.

The top and bottom surfaces of some of the simple compression adobe specimens, as well as the ones with the overlapped adobe with bedding mortar were not perfectly regular. Therefore a capping performed by a thin layer of 1:3 volumetric proportion of cement:sand mortar was applied in all the top and bottom compression specimens (surfaces of simple prisms - Figure 7a - and overlapped specimens that would be in contact with the compression equipment plates - Figure 7b) to assure complete contact of the area that would be in contact with the press plates.

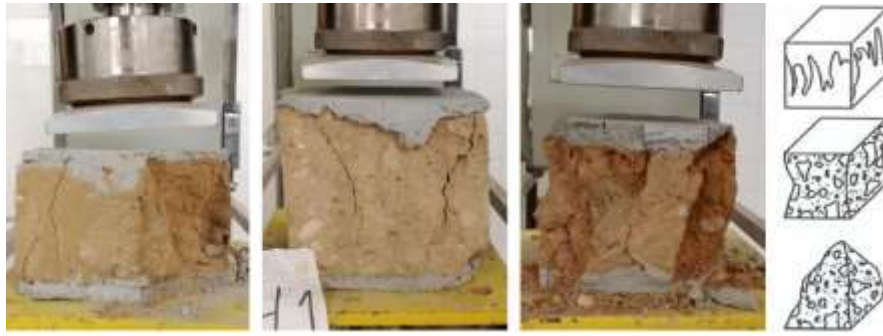
Results of flexural and compressive strength are presented in Table 6. The type of failure resulting from the simple compression test can be seen in Figure 10.

Figure 10. Failure obtained in simple compressed specimens, similar to concrete explosive failure (EN 12390-3, 2019)

Observing the fracture sections of samples after simple compressive tests, case study 267 seems to present lower cohesion, with large dimension voids, which also translates into lower values of compressive resistance (Table 6).
